# **A Labour of Love**

## **The refurbishment of a 1973 long wheel base BMW R75/5**

### **Why I carried out this project and how I did it**

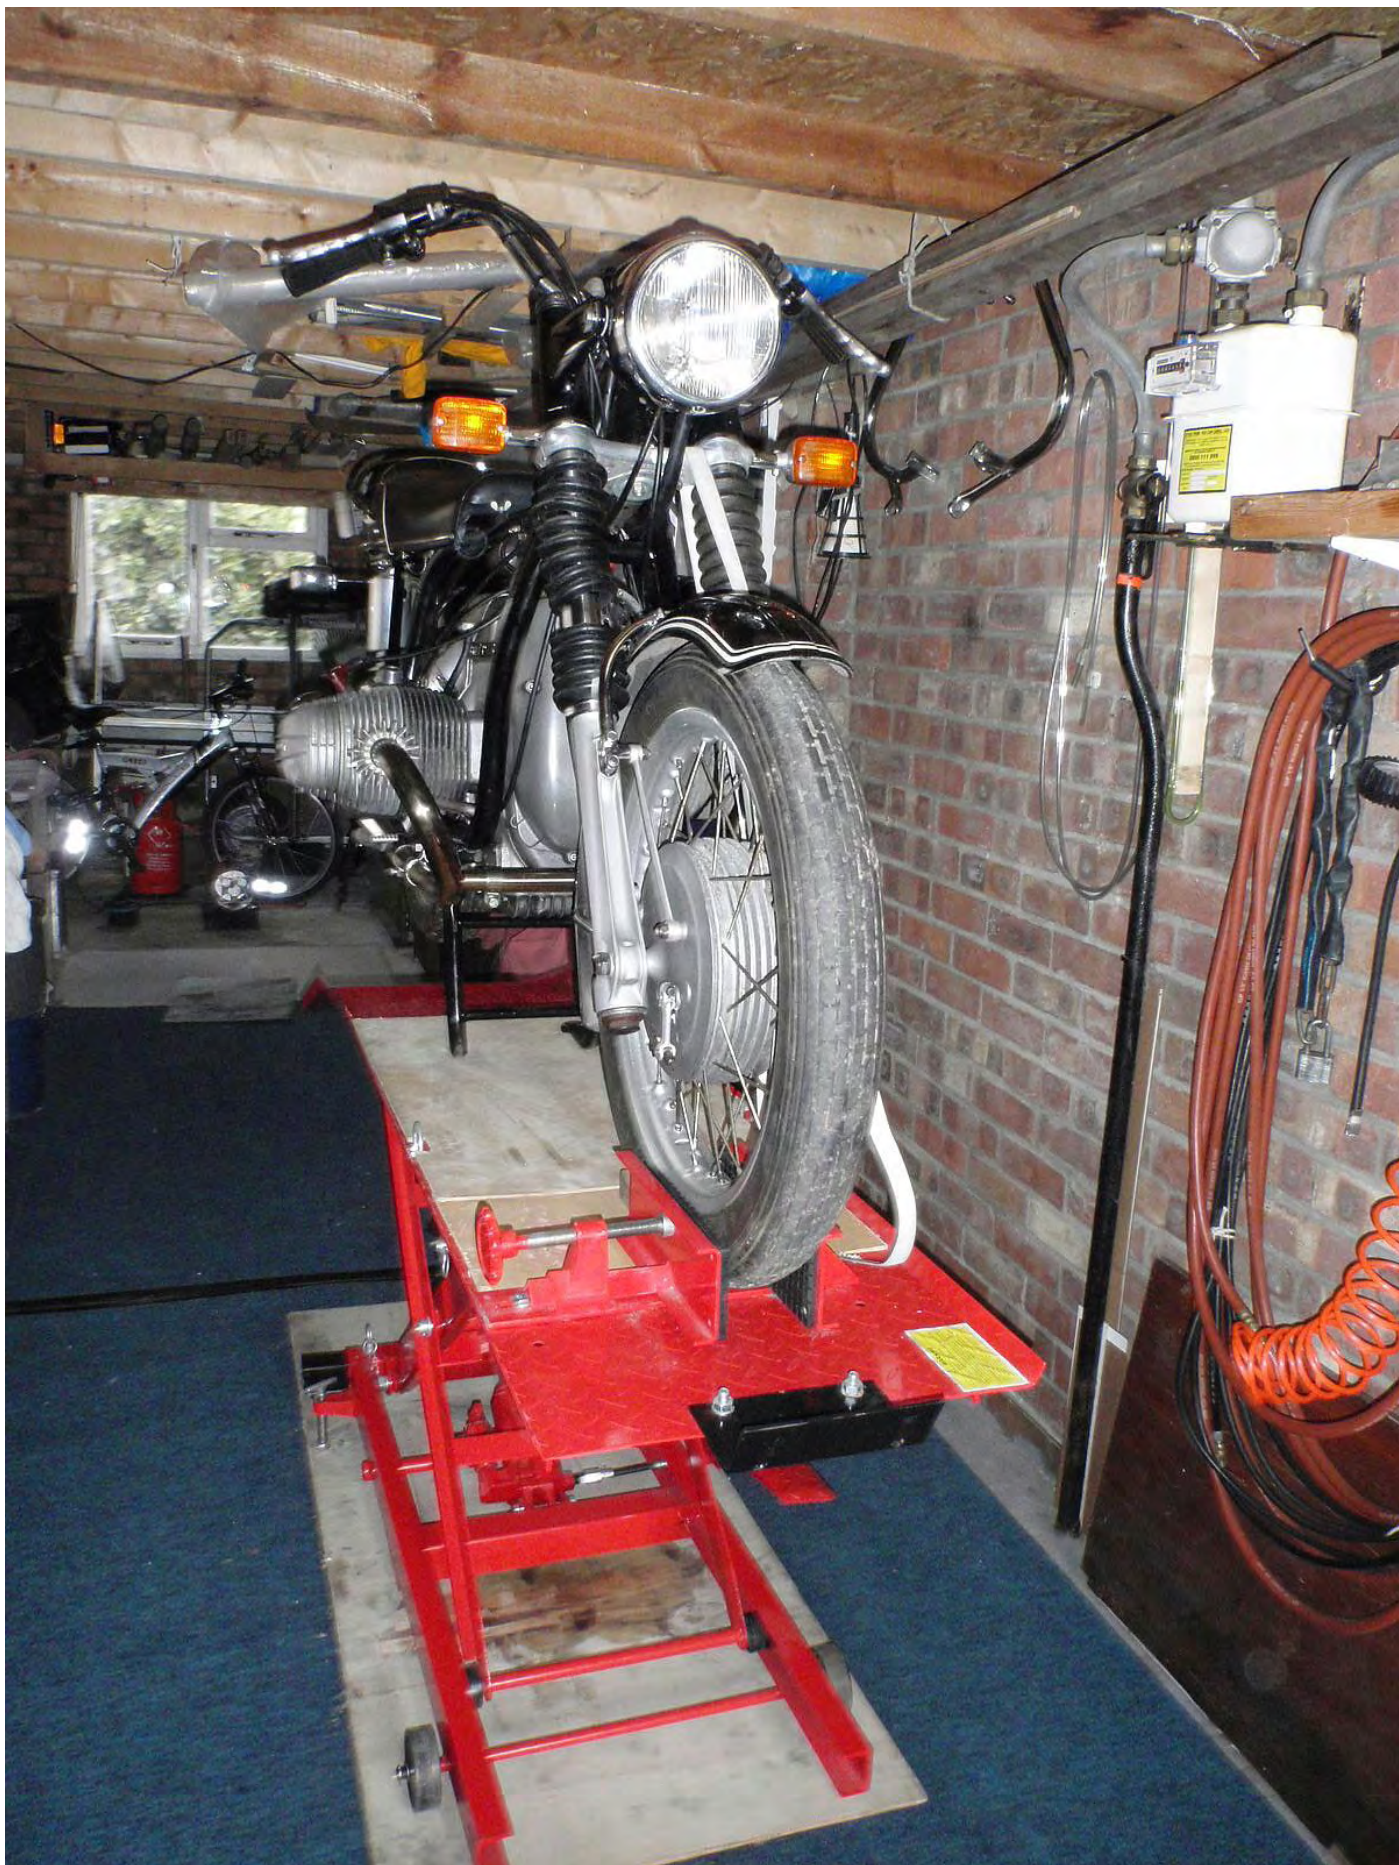
Once home, I unloaded my exciting project, ran the engine briefly again and then wheeled it up on to my hydraulic lift to carry out the refurbishment.

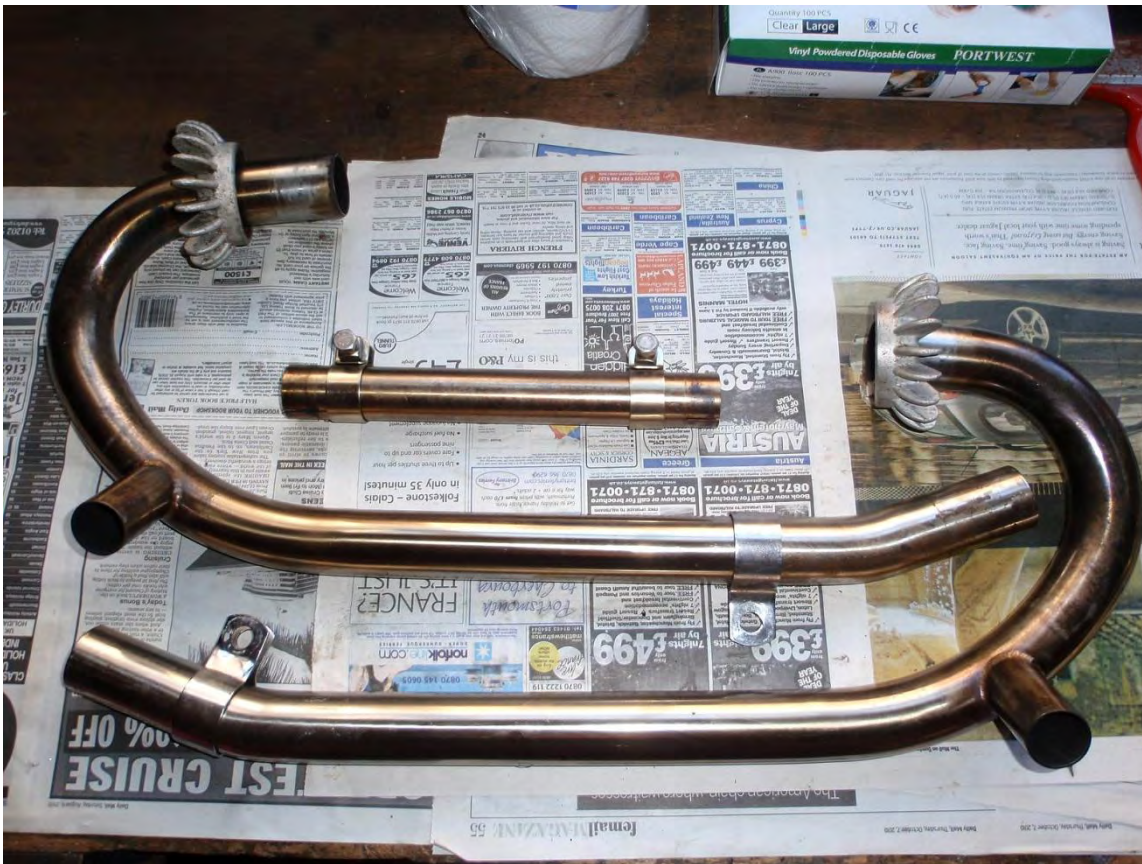
### **Exhaust System**

This had all been replaced in stainless steel and after removing it, I gave it all a good polish and put it away in storage. It is interesting to note that all through the work I had no problems with undoing any fastening!

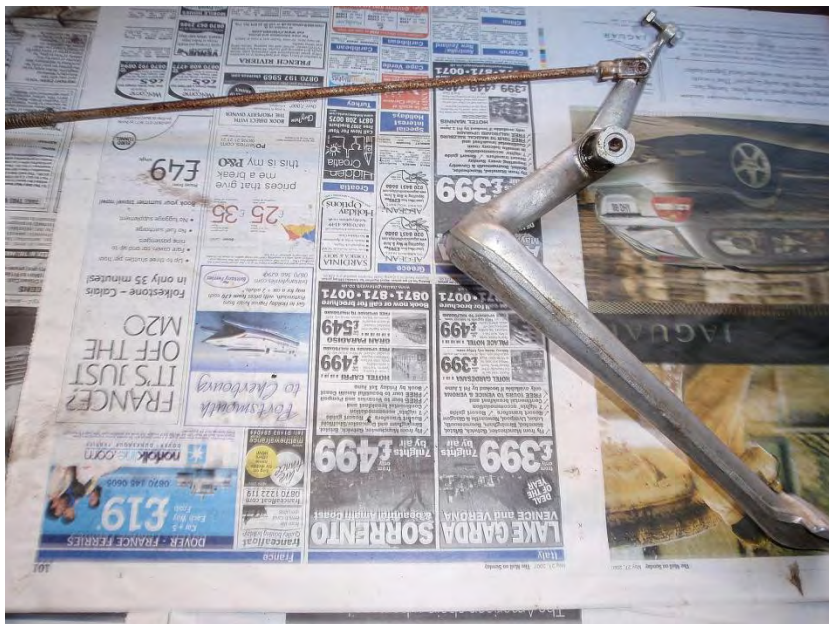
### **Rear Brake Lever**

Next I removed the rear brake lever complete with rod and stop switch, cleaned them all and put them in the storage box after painting the rod in silver paint.

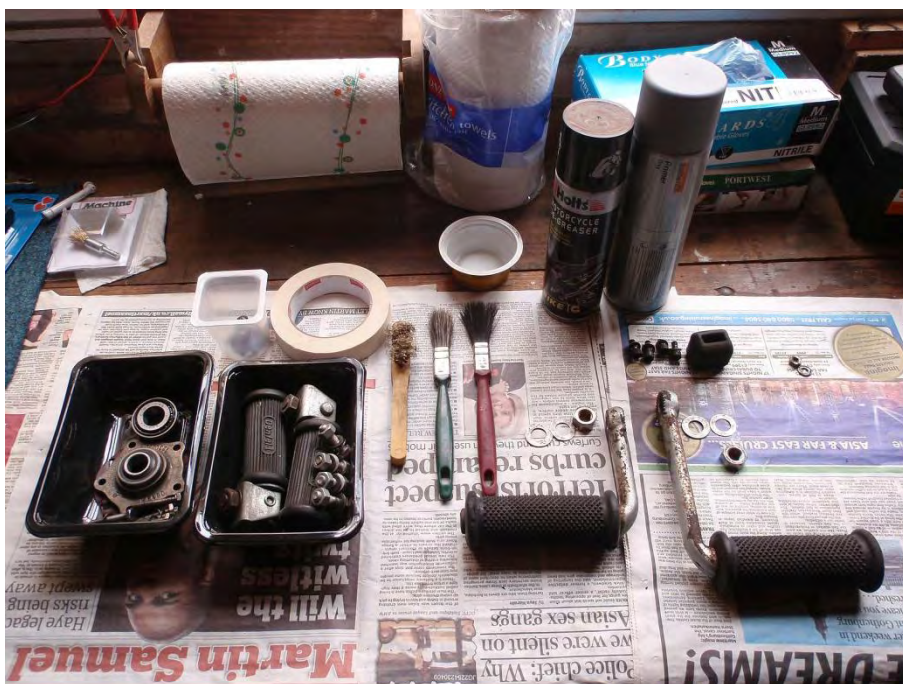
This photo shows various items removed around this time – front and rear foot rests etc.

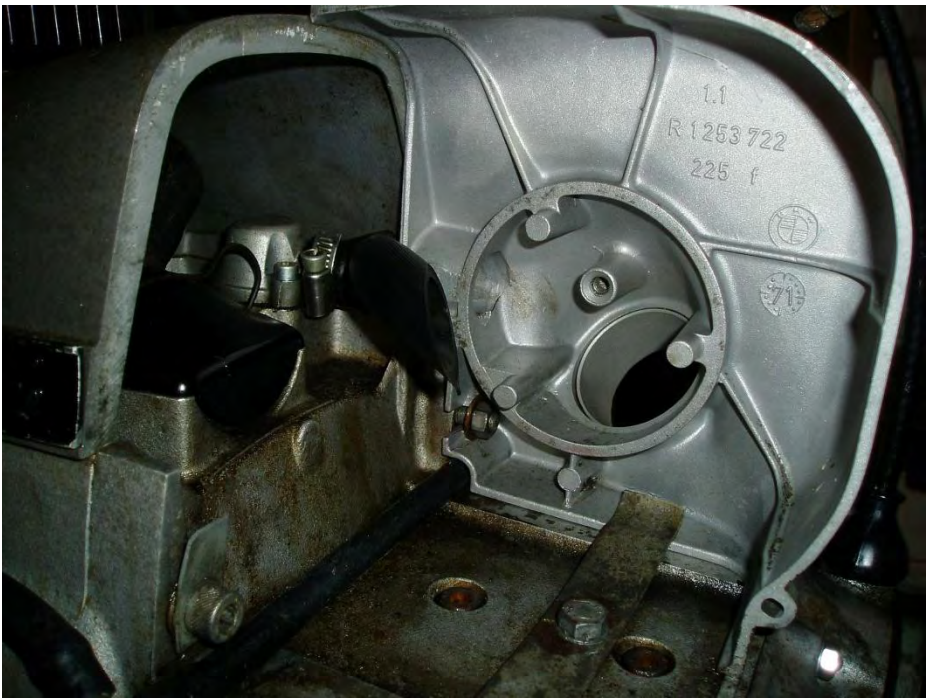
These were removed and the breather pipe was seen to be incorrectly routed – not going through it's designated hole in the RH airbox casting!

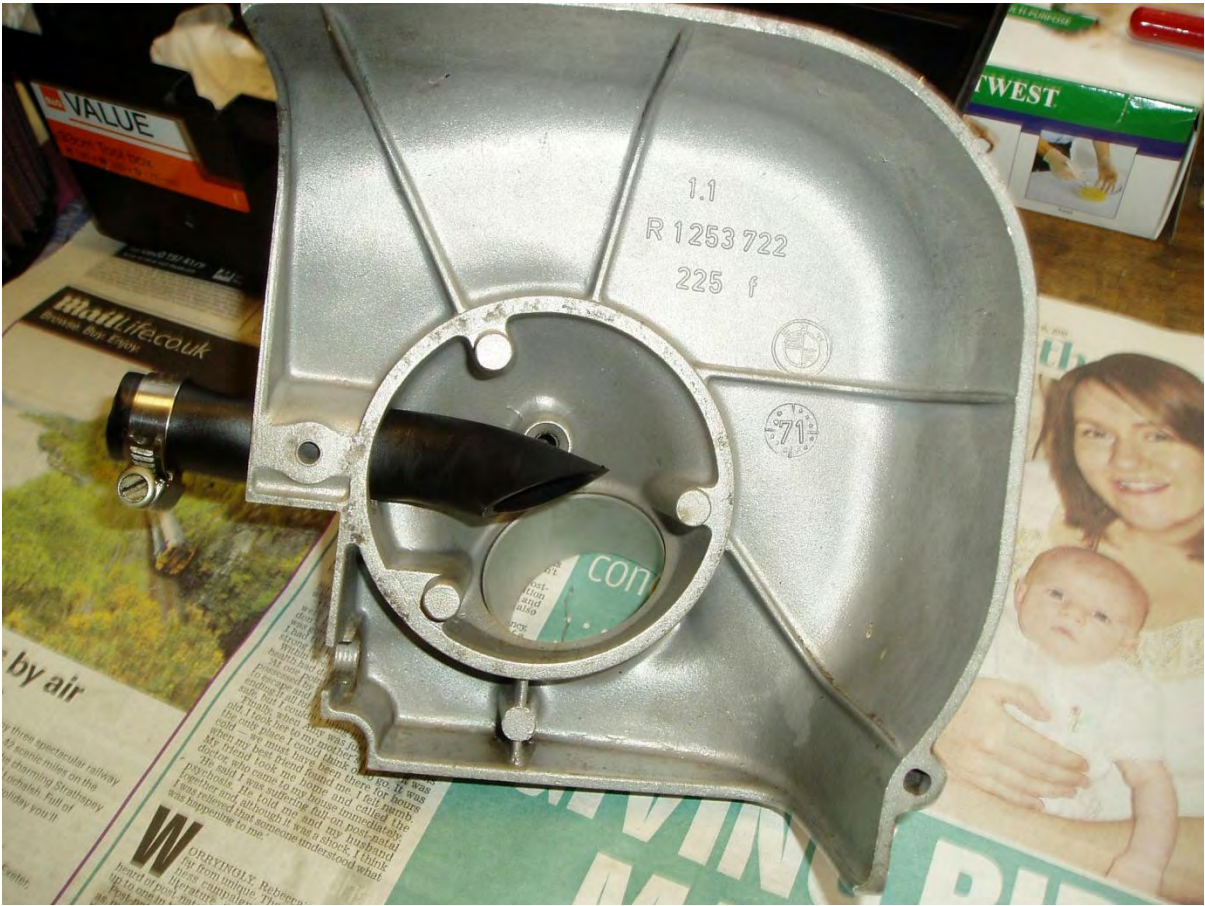
Photo below show correct route for breather pipe from crank reed valve.

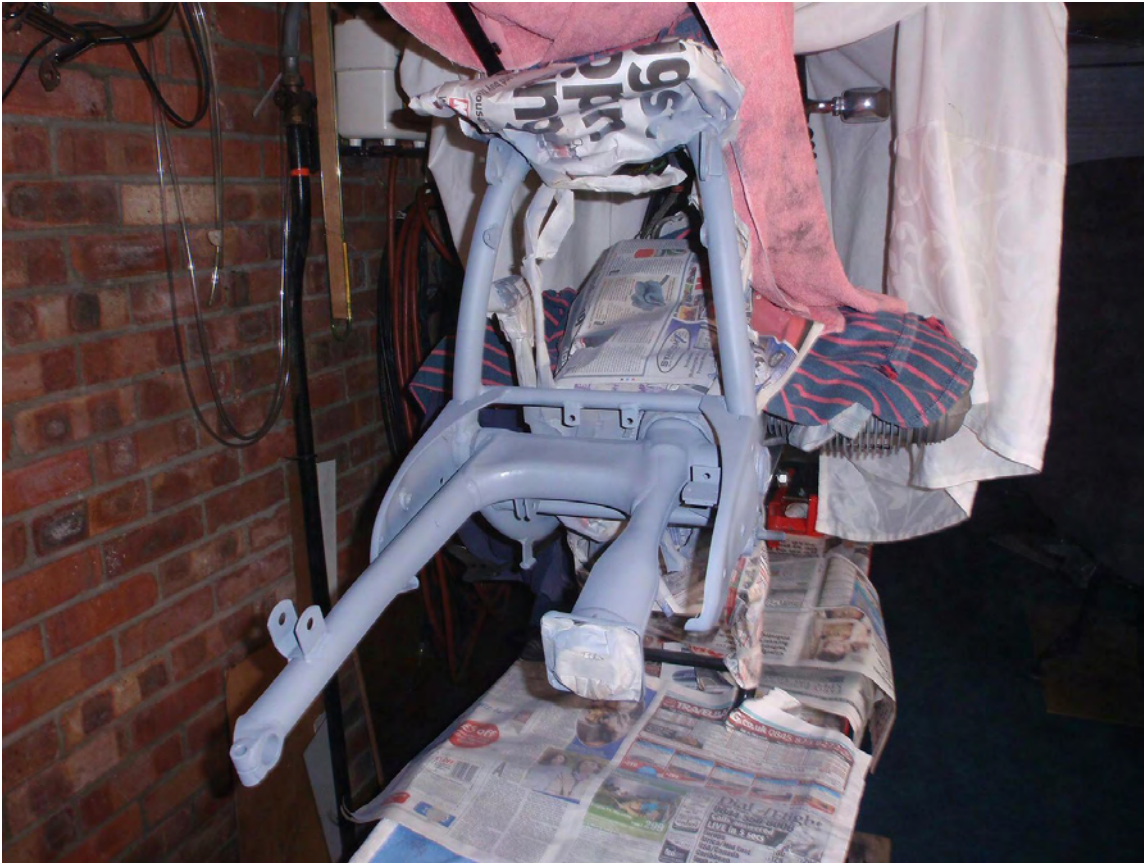
This shows the rear of the main frame with 2 coats of primer.

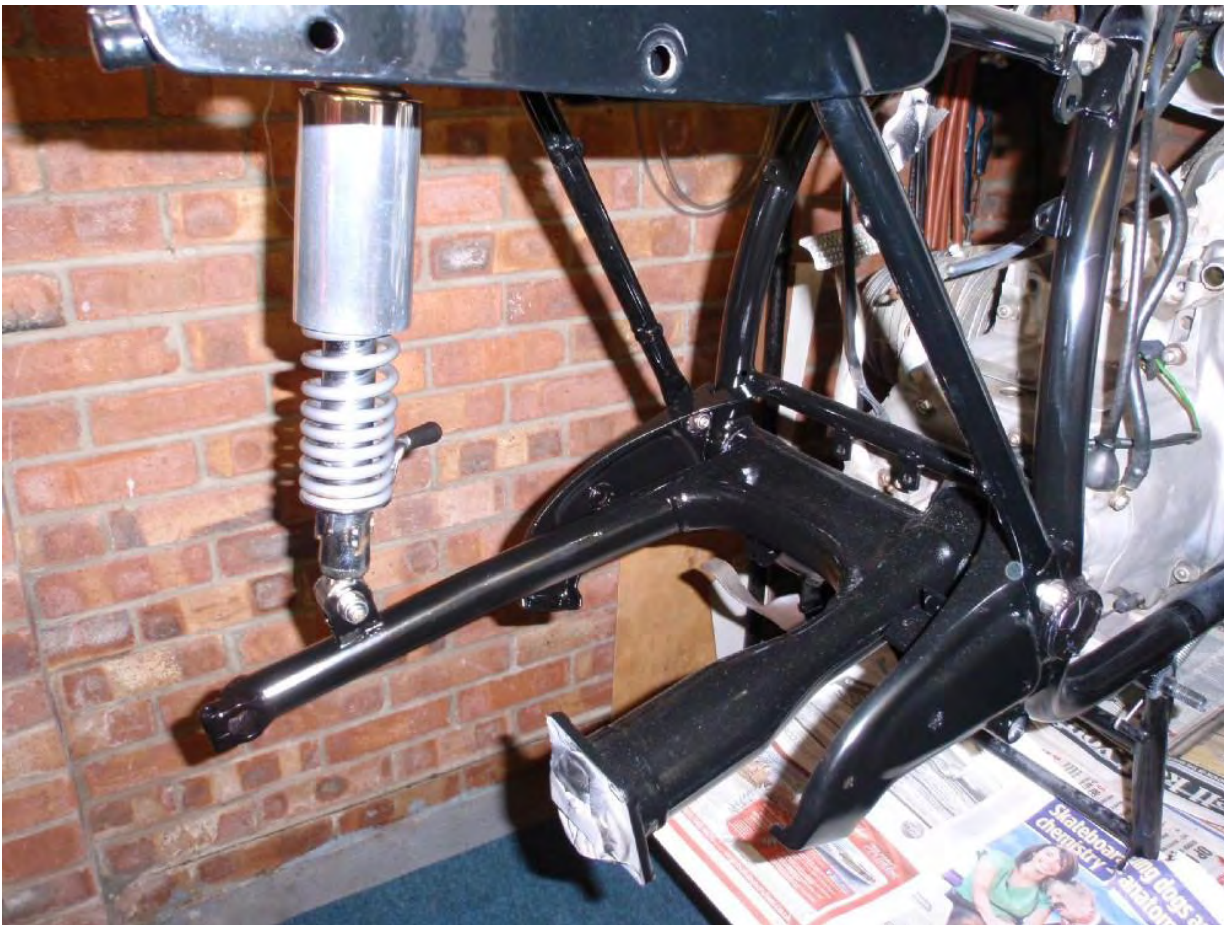
This shows the 2 coats of black gloss applied and removable frame refitted

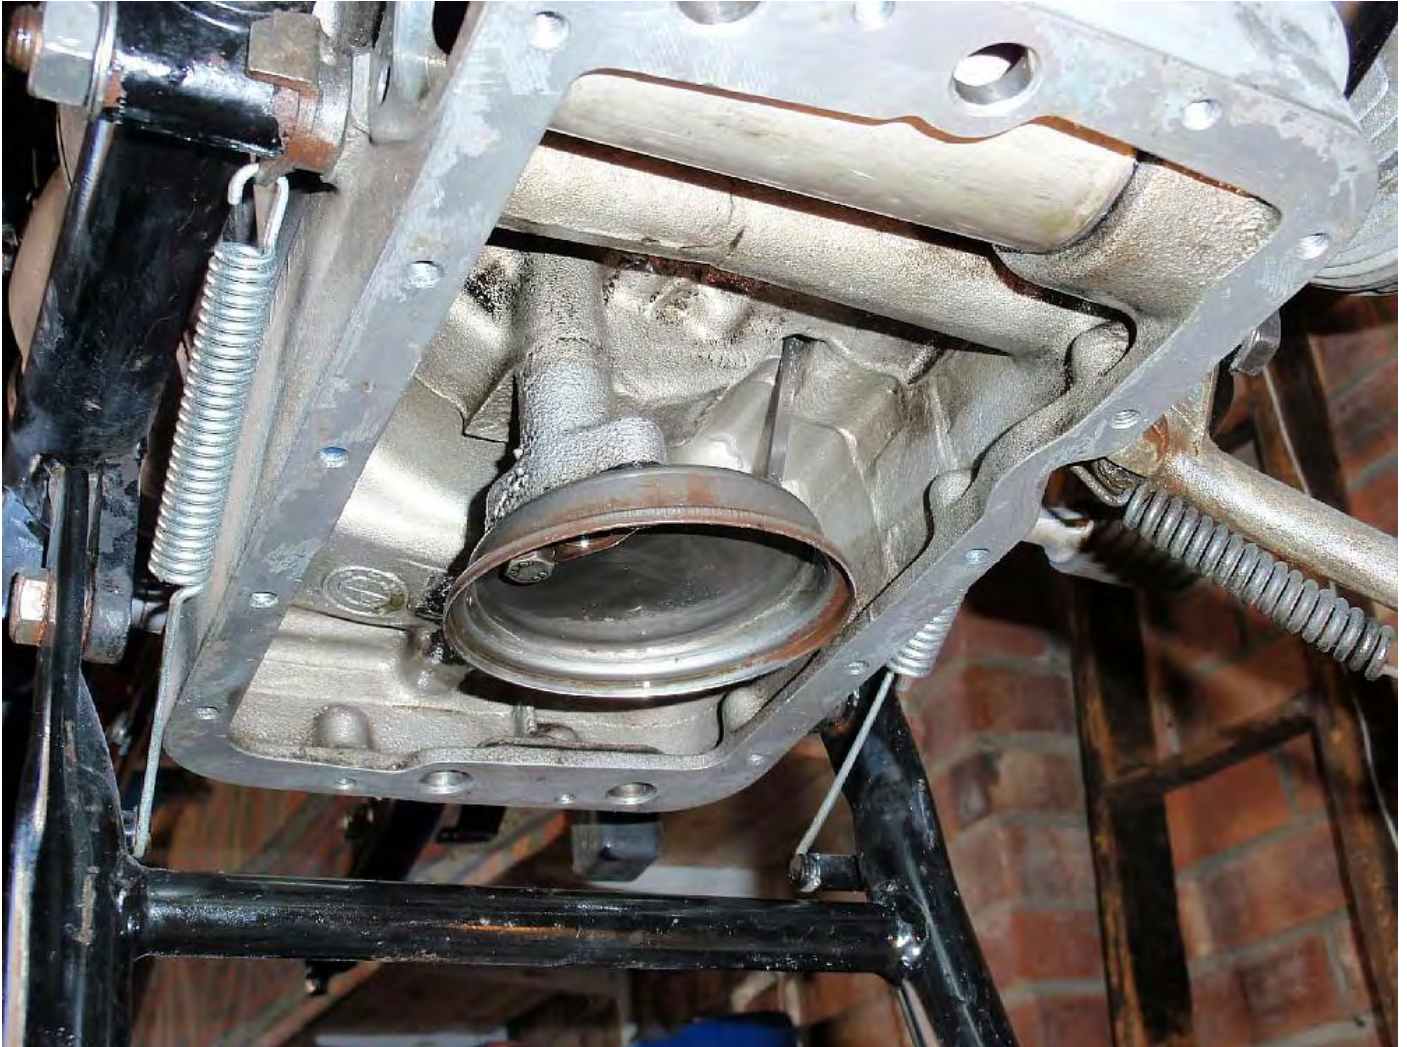
## Sump and Oil Filter Removal

The joys of the hydraulic lift allows this sort of work and photo without a problem!

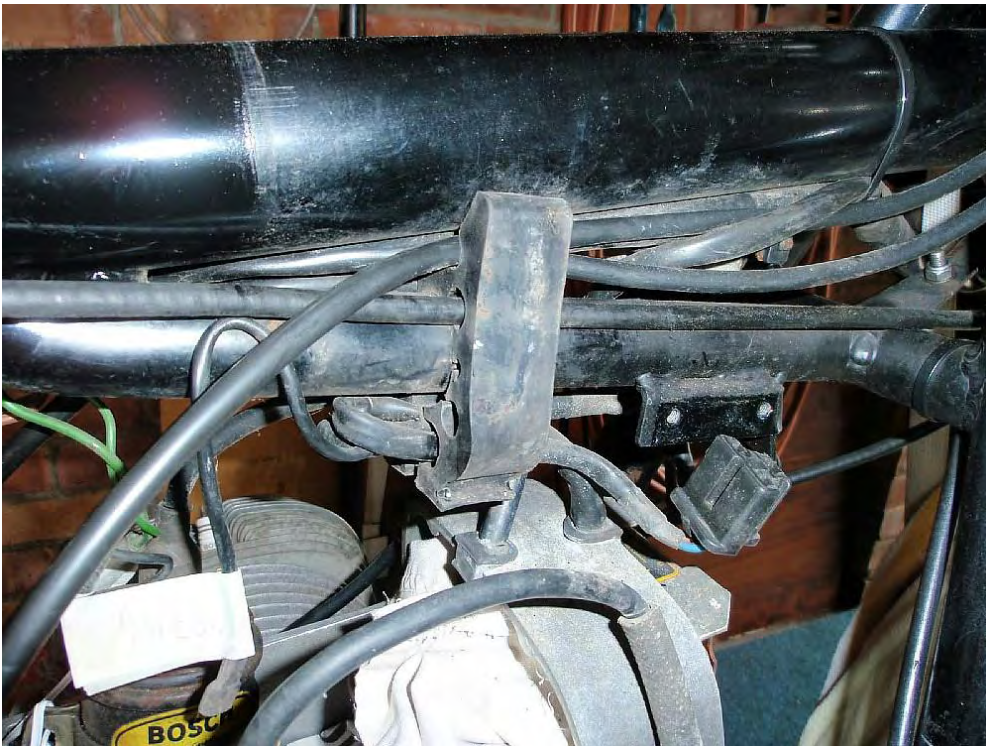
### Wiring Loom under tank

I needed to straighten up a little after the sump work, so decided to check and clean the wiring loom – that mass of wires usually hidden by the tank! I am not an electrical wizard but will tackle what needs to be done. Luckily, before any dismantling I had checked that all the electrics and switches worked – they did!

So all this needed was a good clean – I did take it all out of the harness guide and clean all wires.

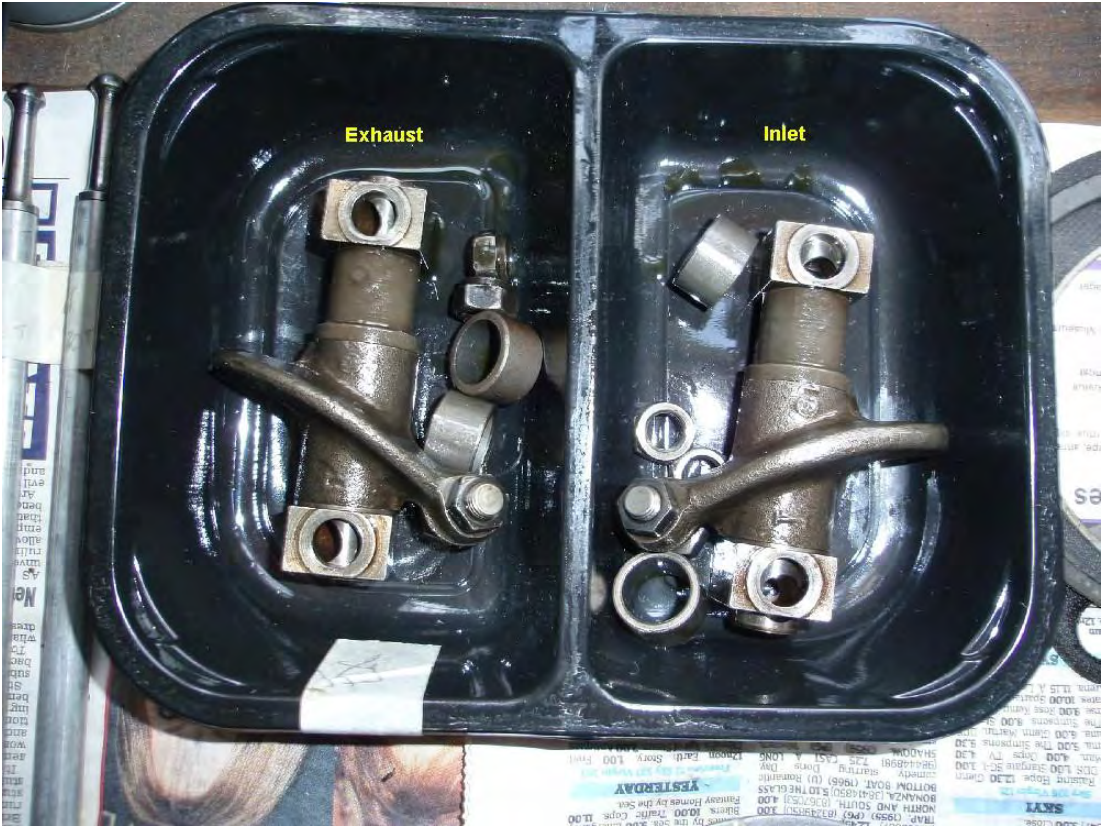
Here are the rockers off the LH head in their Tesco tray!

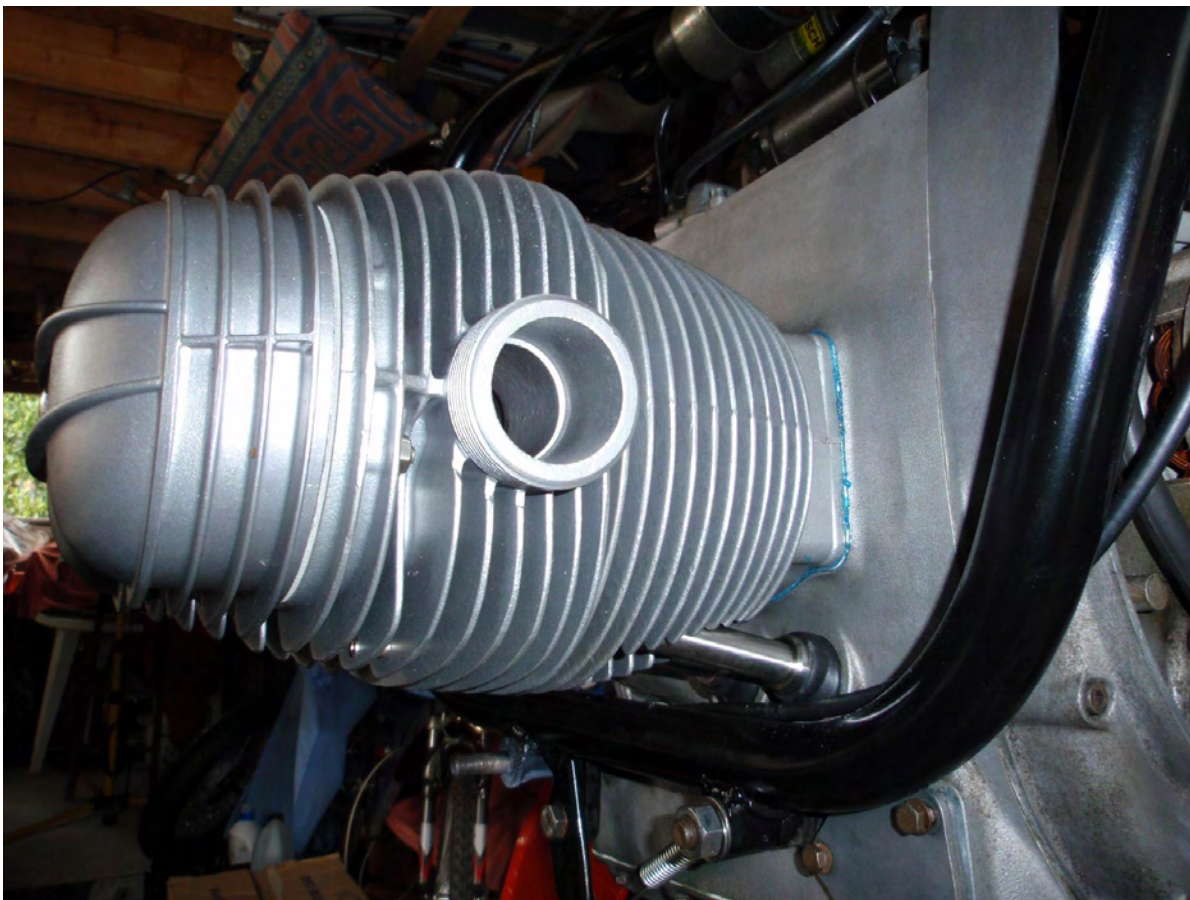
This photo shows the RH barrel, head and rocker cover refitted with valves correctly adjusted.

Note Hylomar gasket glue and barrel/block joint and new stainless steel pushrods with new rubber seals. The forward parts of the main frame have also been sprat painted.

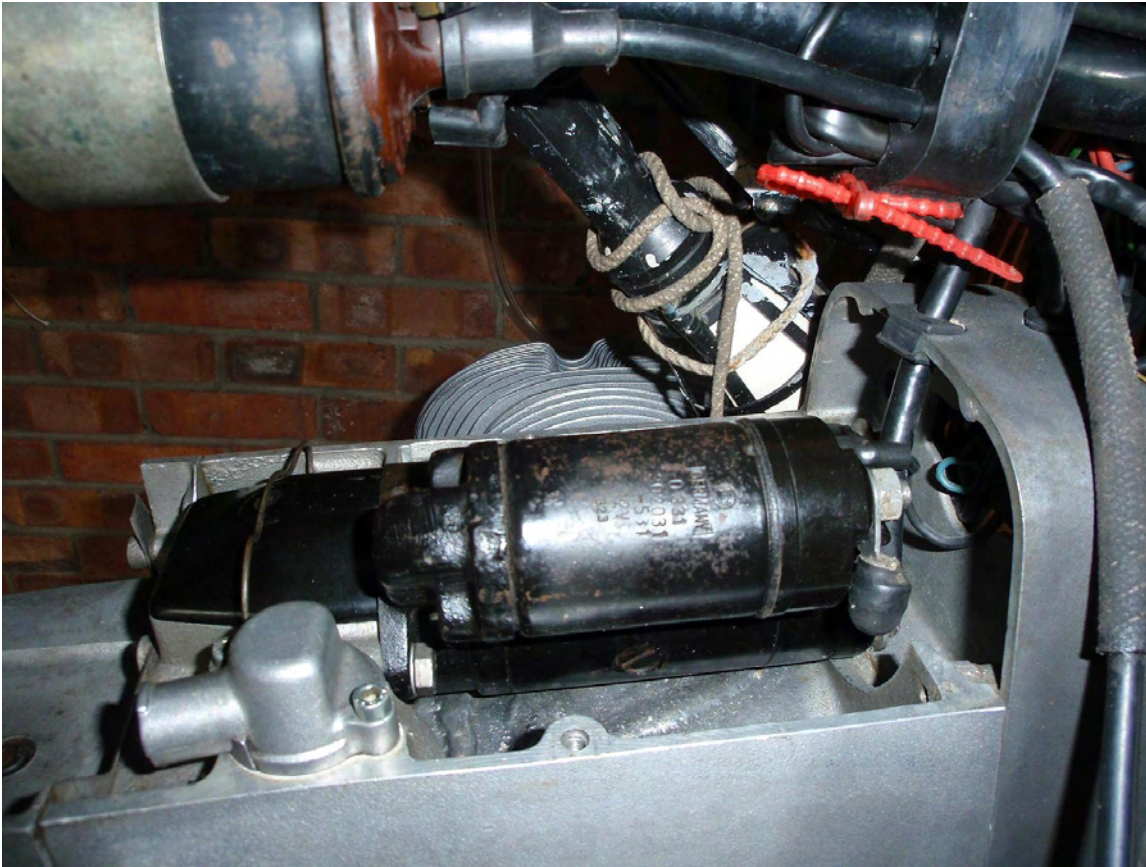
**Next the starter was refitted.**

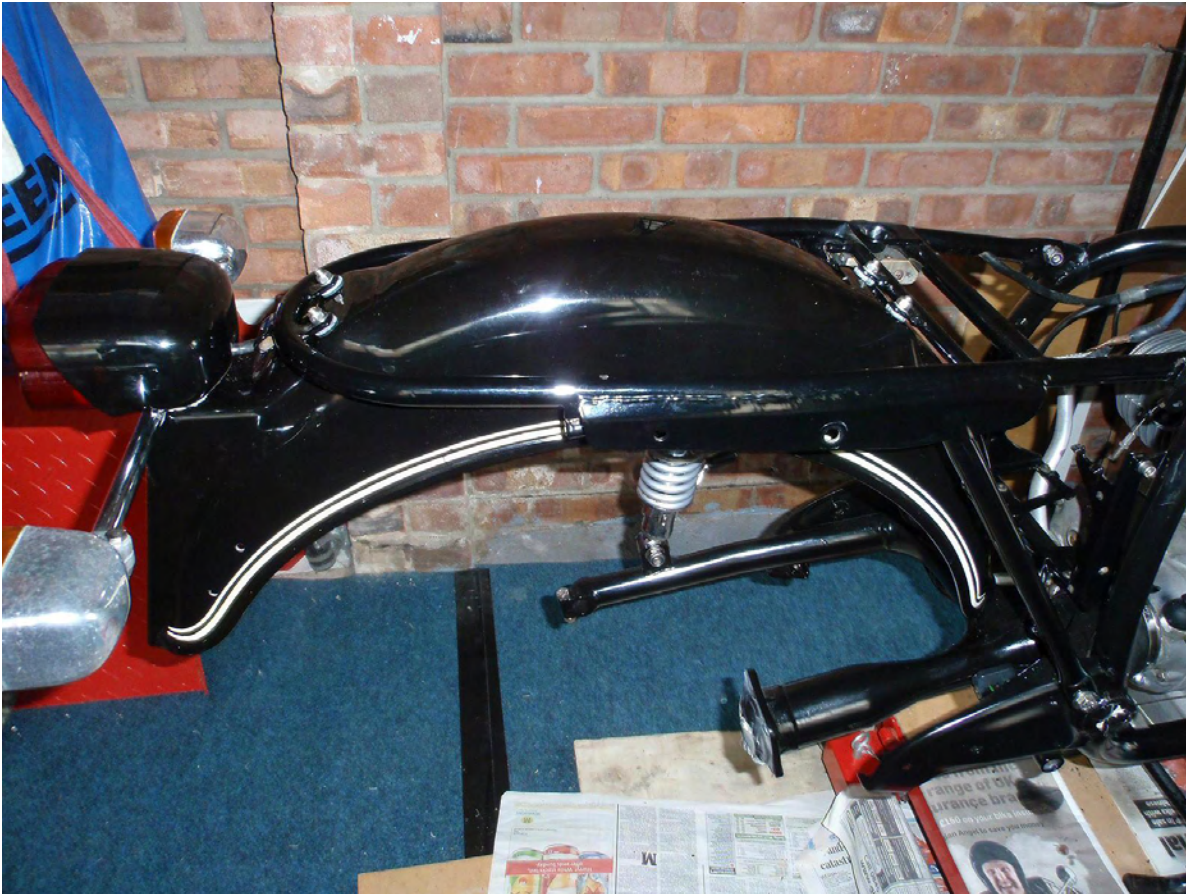
**Rear mudguard refitted**

New rubber washers and new stainless steel lock nuts and washers used.

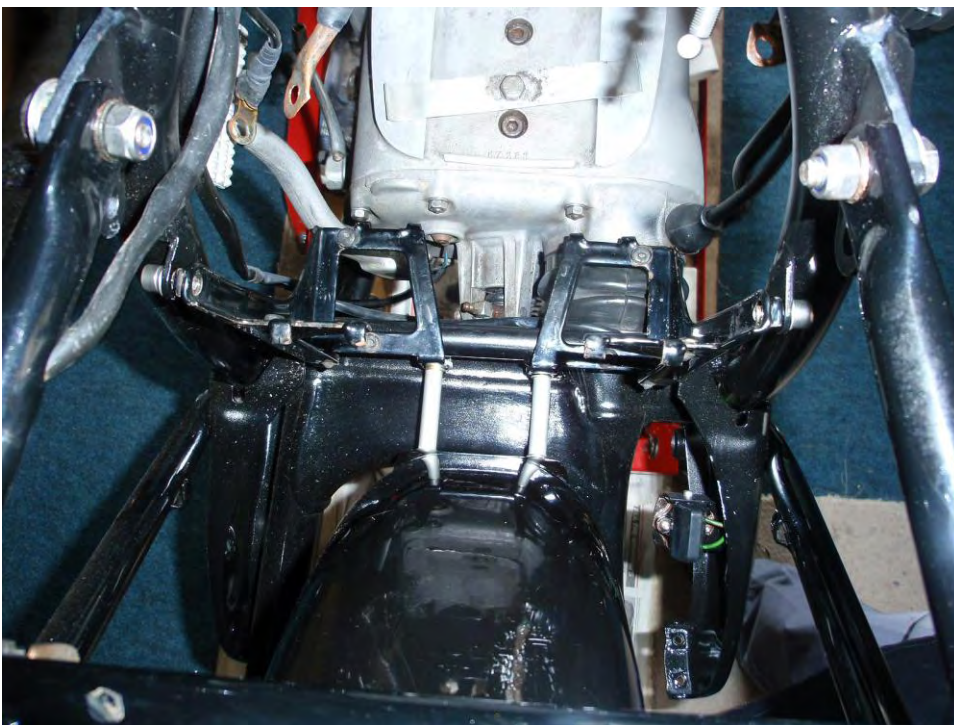
Battery tray fitted and new alloy spacers used on the lower mudguard bolts.

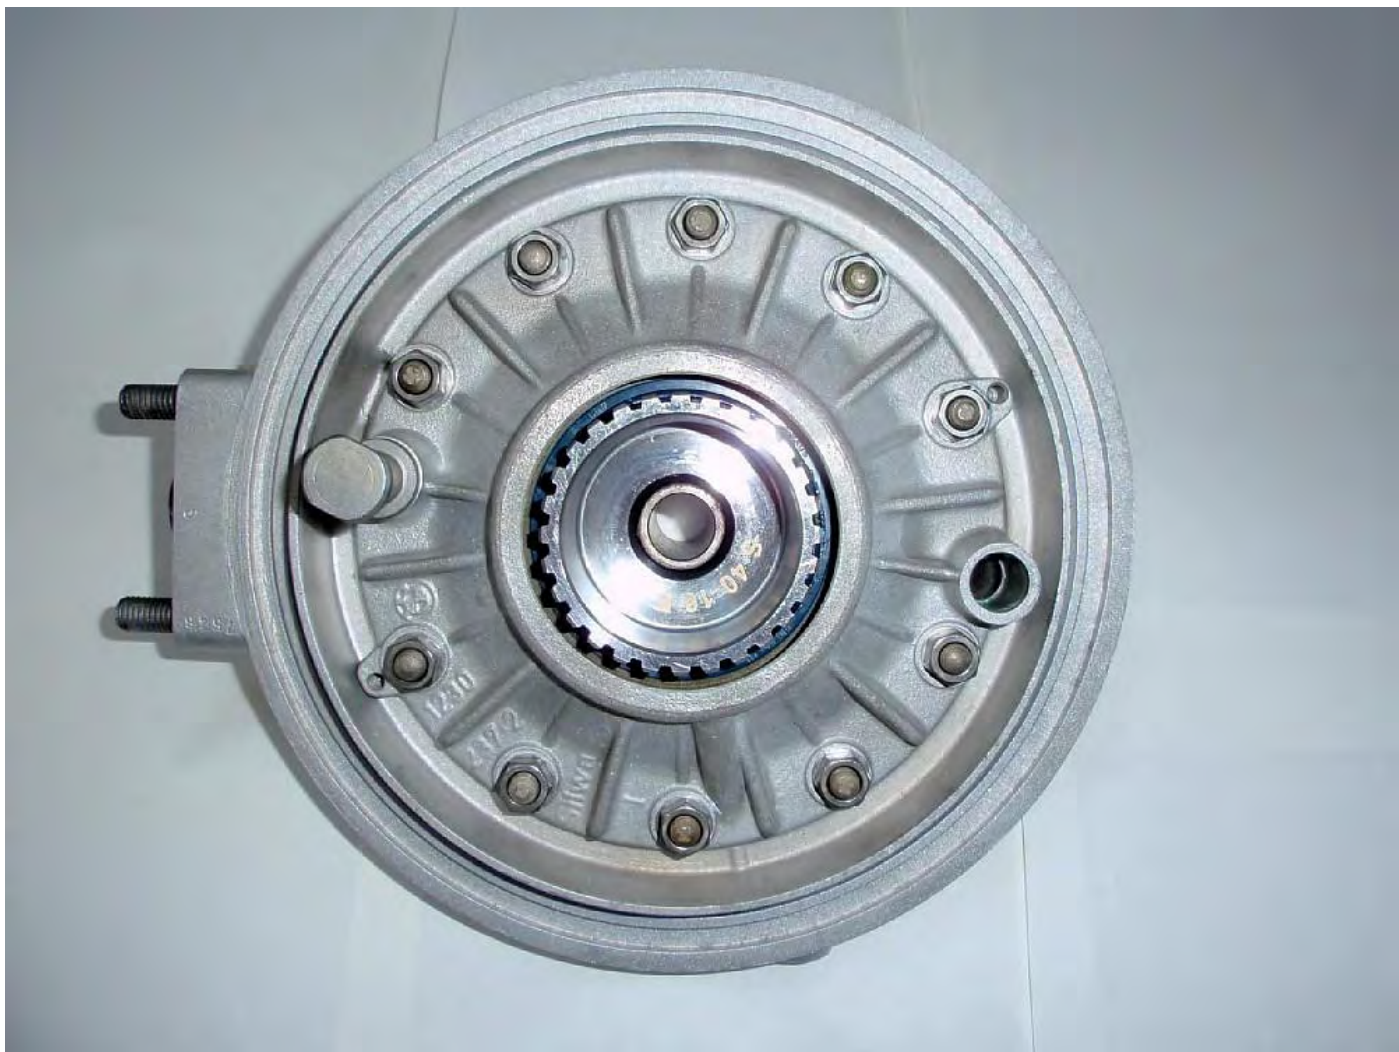
**Bevel Drive with new rear wheel drive splines and vapour blasted**

This had now come back from Motobins and looked superb after Steve Scrimminger had worked his magic.

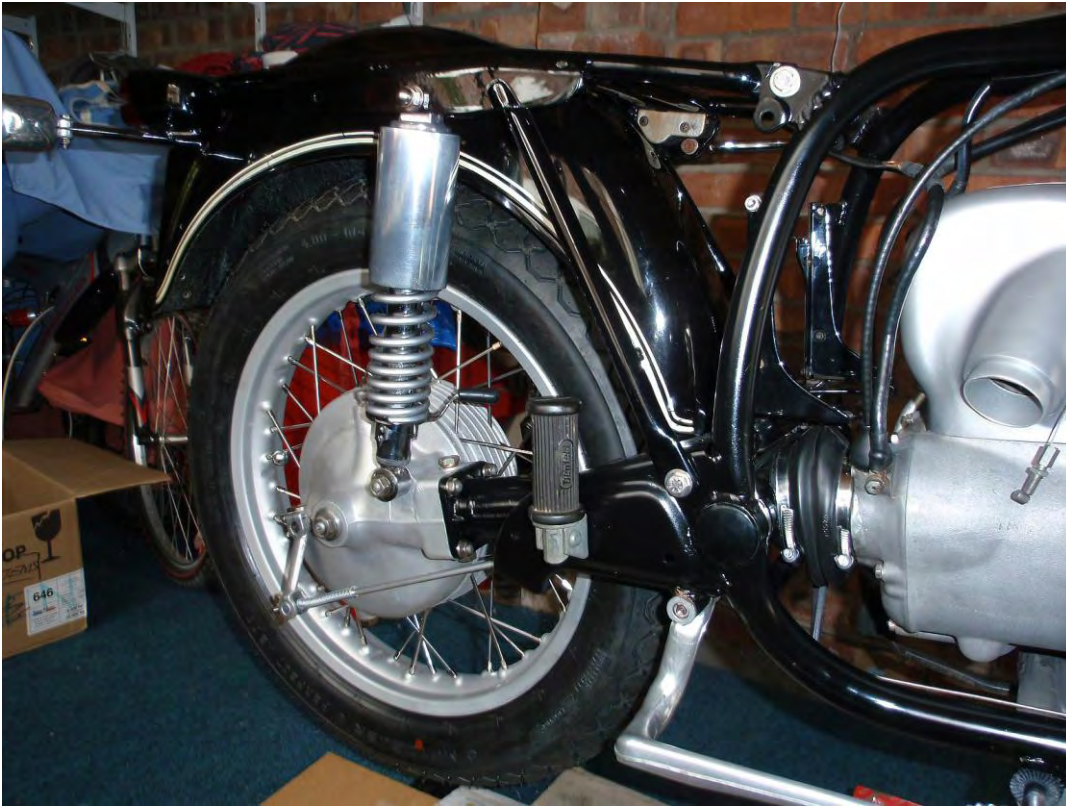
### **Bevel Drive, Rear wheel and Rear brake refitted**

Note new stainless steel spokes and all vapour blasted and new Metzeler tyre and tube

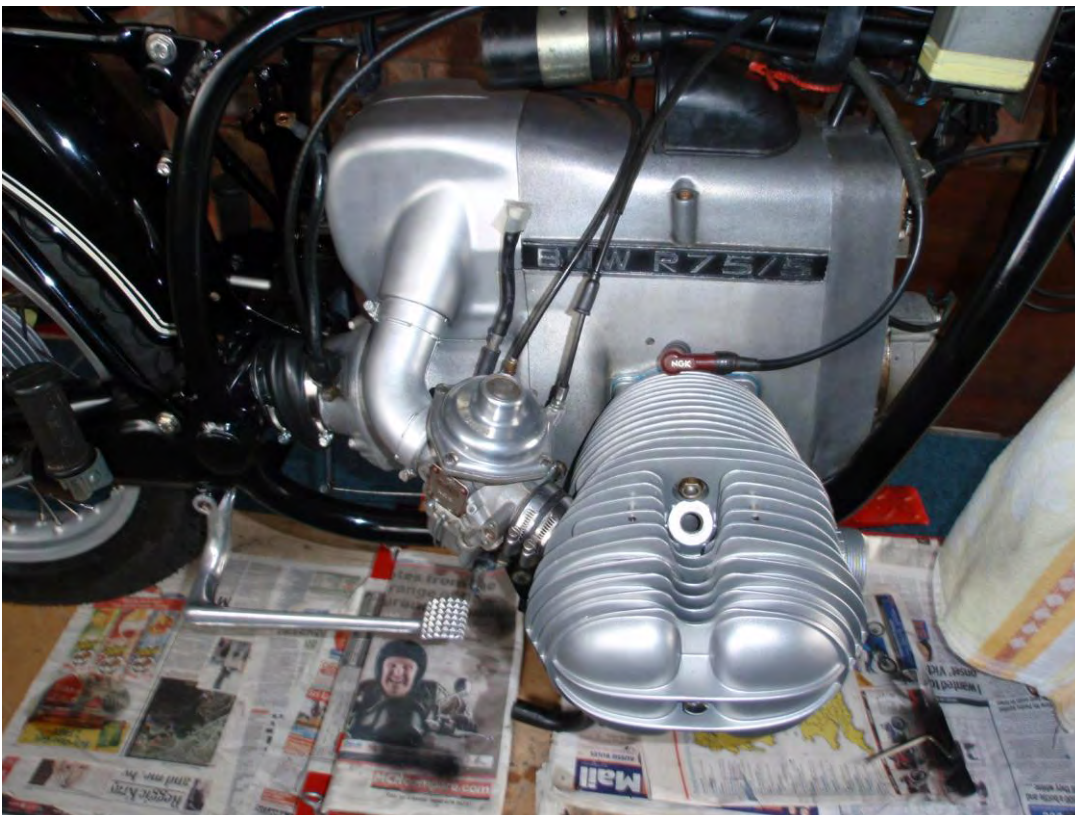
### **Carburettors refitted**

I had cleaned both carbs and checked them visually but was to discover some problems after running the bike – see later!

The carburettors were still giving trouble so off they came for a complete check over.

I was getting persistant drips from the left hand carburettor and on dismantling, discovered a leaking float!

I stripped both carbs, blew out all airways, replaced the "o" rings where necessary, replaced the float assemblies and float needle jets and reassembled all.

Still a leak from the RH carb! I must have adjusted the float level half a dozen times until I discovered the cause.

The float bowl has a tiny brass capillary like tube which is the overflow should the needle valve stick – this is what I thought was happening, but oh no! Where this thin pipe is fixed in the base of the bowl it was leaking around the hole into which it was pushed!

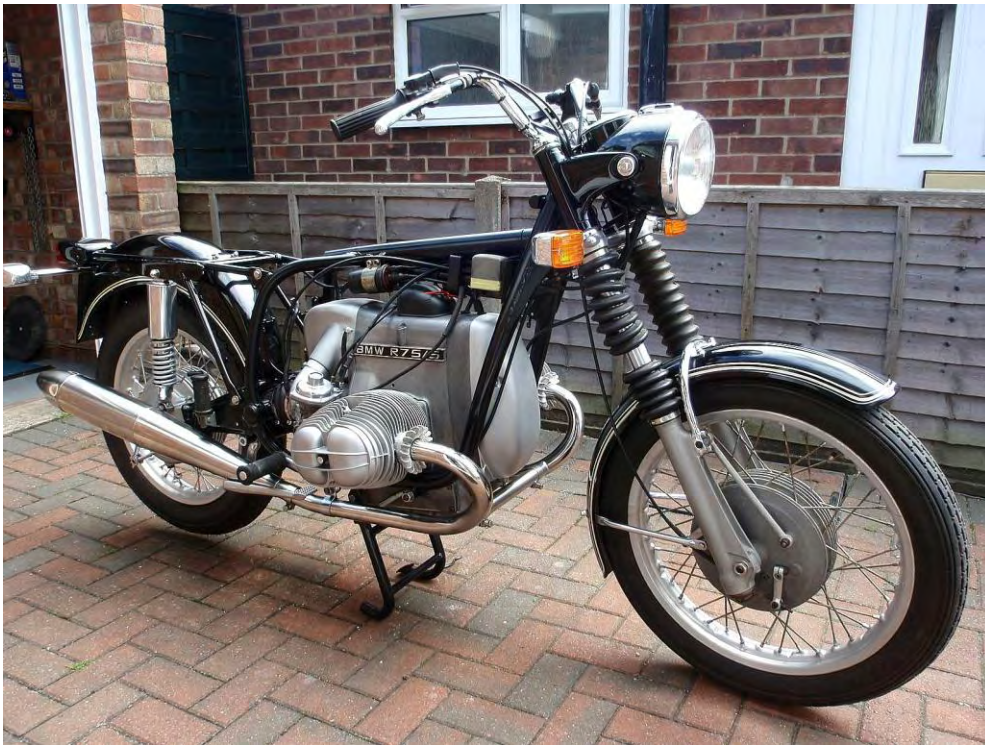
I had bolted the exhaust system back on prior to taking the bike off the lift – new stainless steel bolts to attach the silencers. Front wheel not yet rebuilt – went off to wheel man shortly after this. The bearings were fine so I stripped them and greased them before re-assembly. Note the split gaiter – this is why the bike came off the lift now so I could work on the front end.

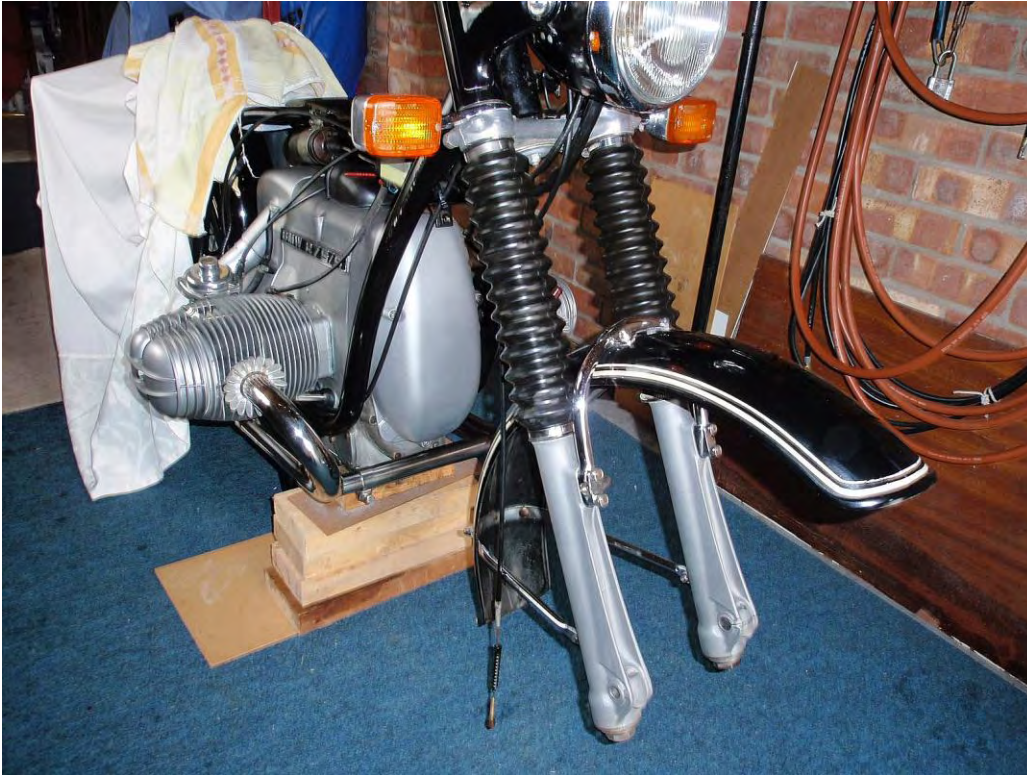
Bike back in garage and front wheel removed and new gaiter fitted to RH side. This was done by releasing the top nut and fork brace clamp nut and lowering the fork complete (mudguard had

been removed). I had assumed the forks were ok – big mistake as I found when later riding the bike – see later for work on forks.

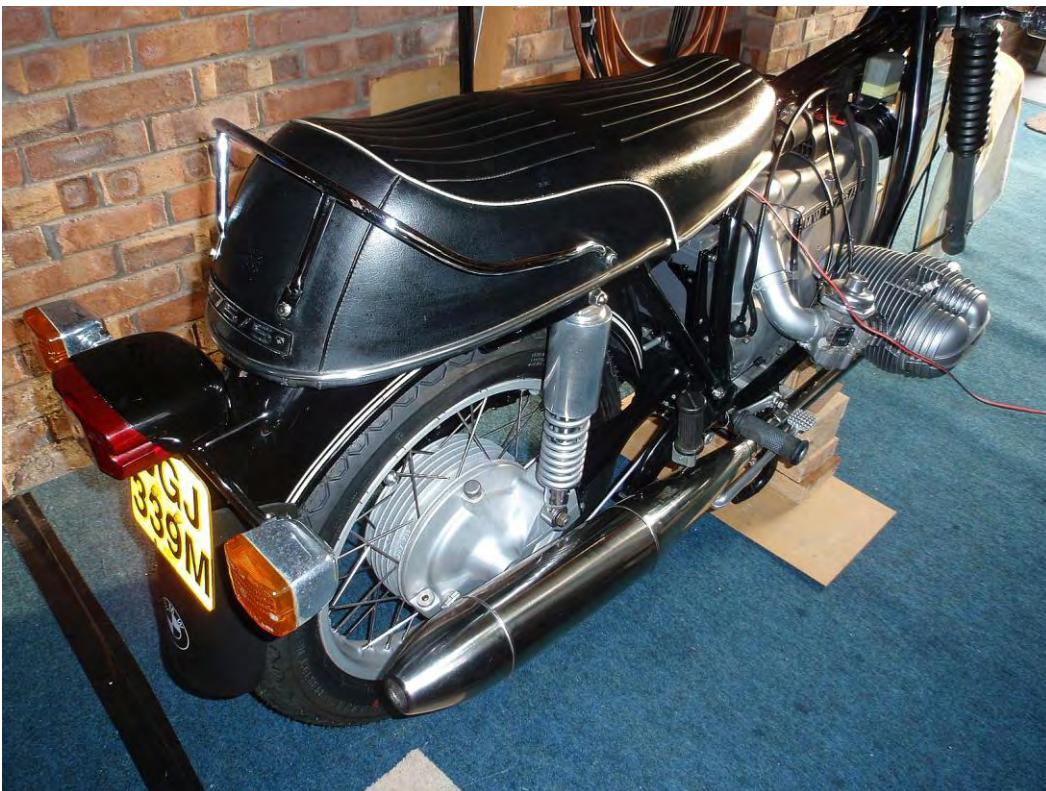
### **Seat, Rear Number Plate and Mudflap replaced**

Front wheel now at the wheel builder – again new stainless steel spokes, vapour blasting and new Metzeler tyre and tube.
