# **A Labour of Love**

## **The refurbishment of a 1973 long wheel base BMW R75/5**

### **Why I carried out this project and how I did it**

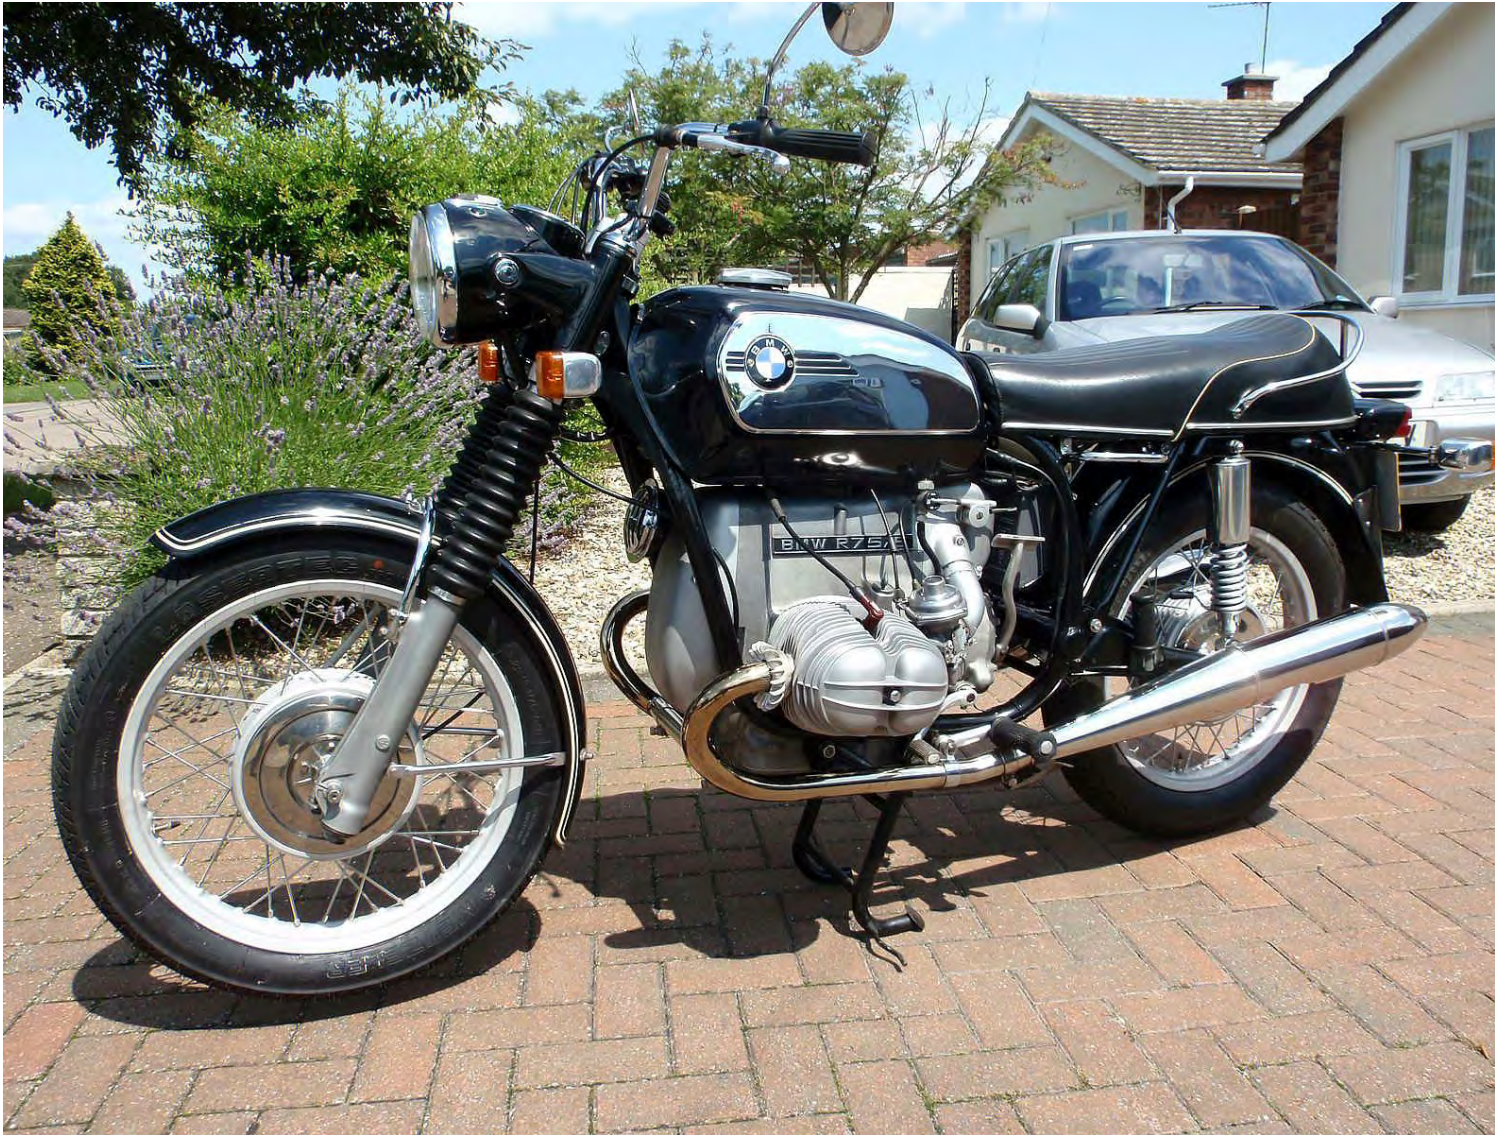
### **Front wheel back and bike ready for first run!**

I had been kicking the engine over for several days after getting it back together just to get the new oil to flow around – it was good to see the yellow oil light go out when only kicking the engine over. I had replaced all oils and filter and fitted new spark plugs. With a gallon of new petrol I cautiously turned on the petrol taps and push the starter – after a few stutters it fired up and I took it for a half mile slow run around the block – the first time running on the road for fifteen years!. Immediately I felt the front brake was terrible so that needed adjusting, the carbs were not right and on a longer run later it was apparent the forks where going down but not coming up!

Back in the garage I removed the front wheel and mudguard and stripped down both forks completely.

Both had large accummations of dirt in the bottom valves and the top valves were completely stuck!

There are very few parts actually needed to replace inside the forks, they just needed a good clean out to ensure all moving valves worked.

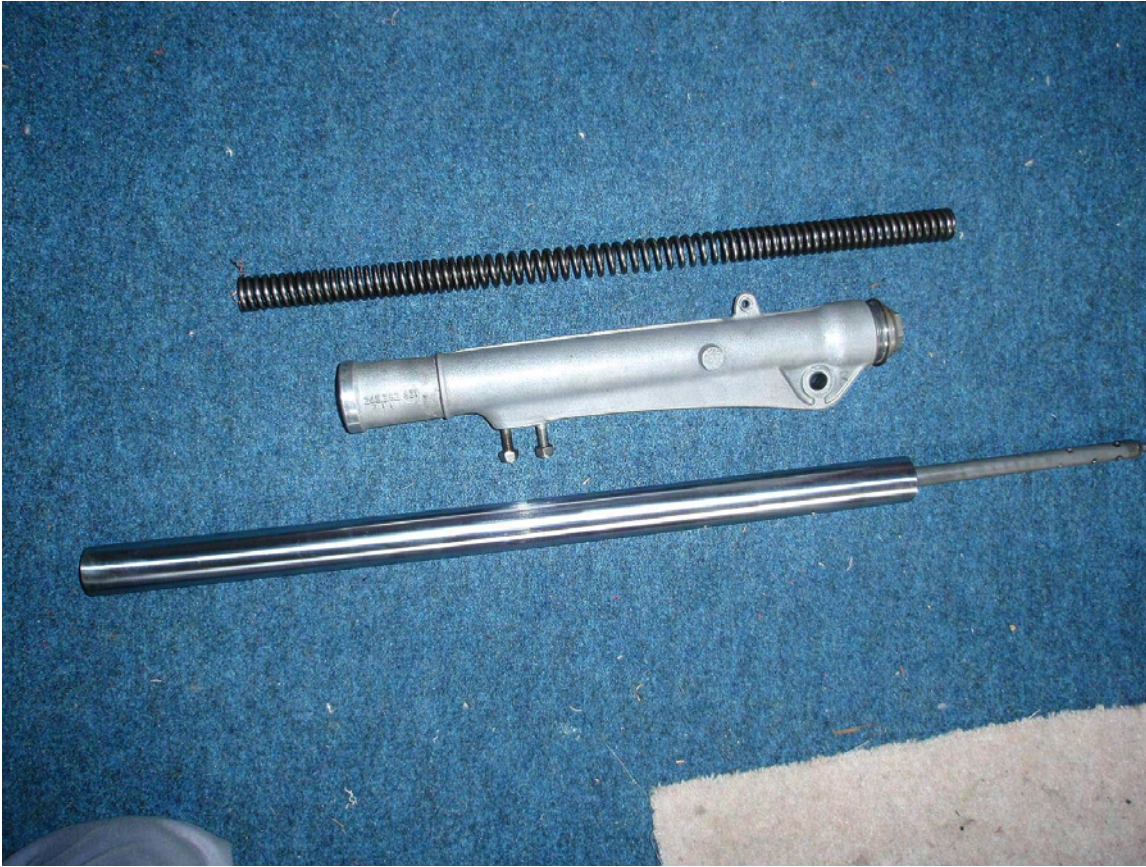
I measured the spring lengths whilst dismantled – both were exactly the correct length!

I also used my engineers heavy cast flatplate to check that both stanchions were straight – they were!

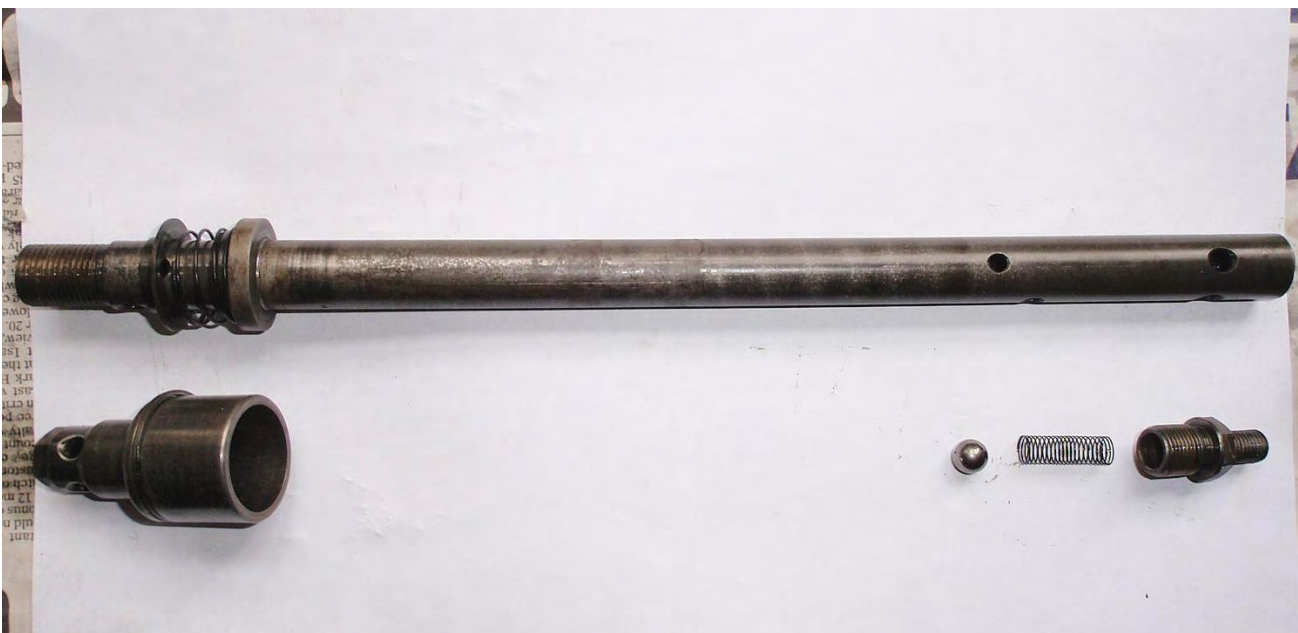
### This is the Damper Rod taken apart.

The sprung slider on the left was stuck on both forks and where the ball and spring on the right locate, the tubes was full of dirt.
